PANAMA CITY OFFICE
7500 McElvey Road, Ste. A
Panama City Beach, FL 32408
Tel: (850) 769-4773
Fax: (850) 872-9967
www.soearth.com

December 12, 2024
File No: P24-547

Subject: Geotechnical Services for the Seawall Repairs at the Mexico Beach Boat Launch in Mexico Beach, Florida

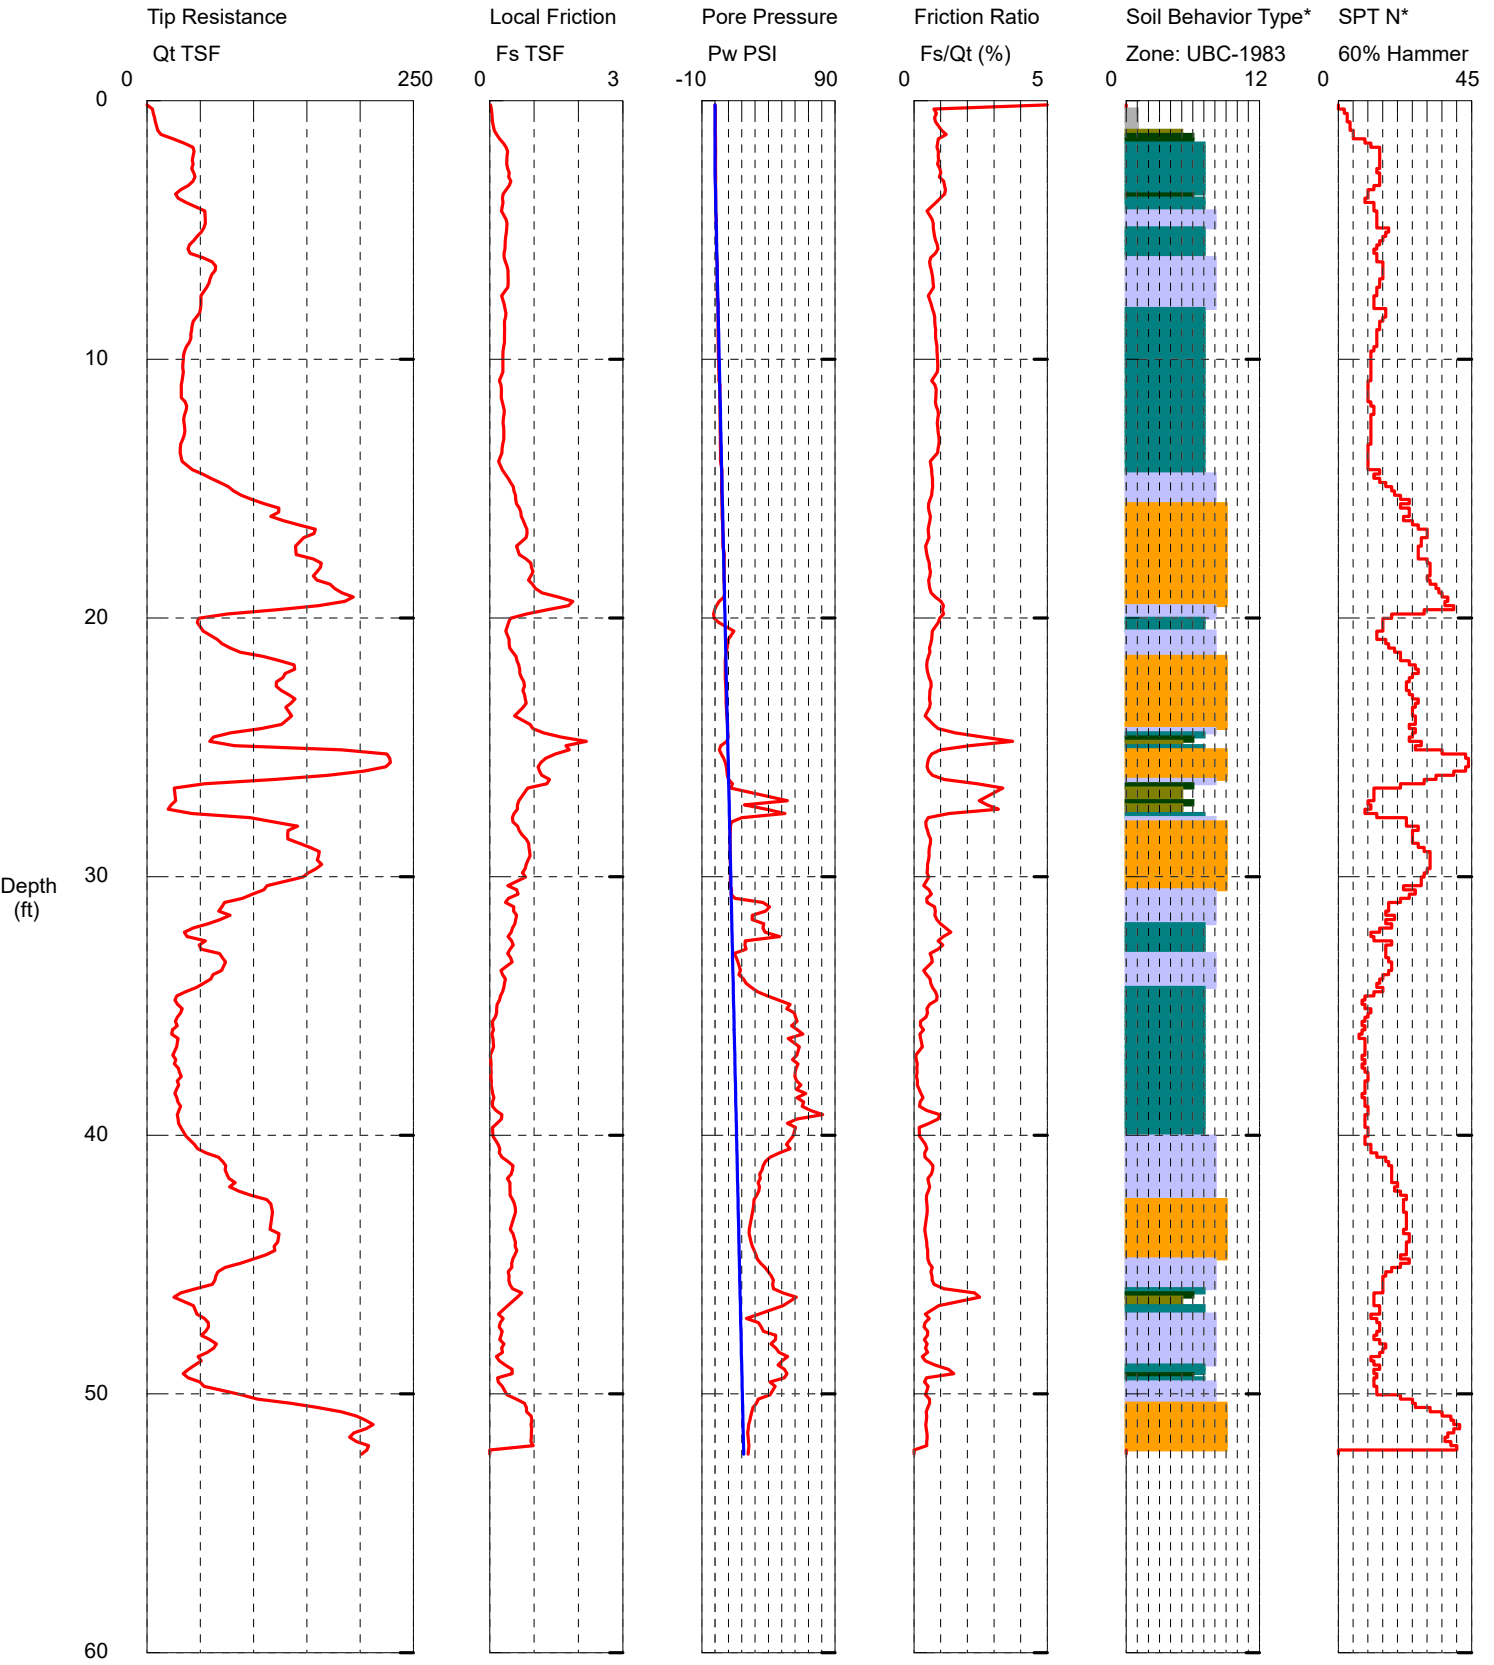
Operator: Pat Conroy
 Sounding: C-1
 Cone Used: DDG1702
 Groundwater: 4.5 feet

TABLE I: Test Location C-1**

Depth:	USCS Classification	Friction Angle (°)	Cohesion (lbs/ft ²)	Unit Weight (lbs/ft ³)
0 – 3 ft.	SP-SM	28	0	90
3 – 15 ft.	SP-SM, SP	29	0	50
15 – 20 ft.	SP, SP-SM	34	0	54
20 – 26 ft.	SP-SM	30	0	50
26 – 28 ft.	SC, SM	28	0	45
28 – 33 ft.	SP-SC, SP-SM	31	0	51
33 – 40 ft.	SC, SM	28	0	48
40 – 45 ft.	SP-SC	32	0	53
45 – 50 ft.	SC	30	0	49
50 – 52 ft.	SP	36	0	56

Estimated ground elevation at location C-1, approximately +6 Ft

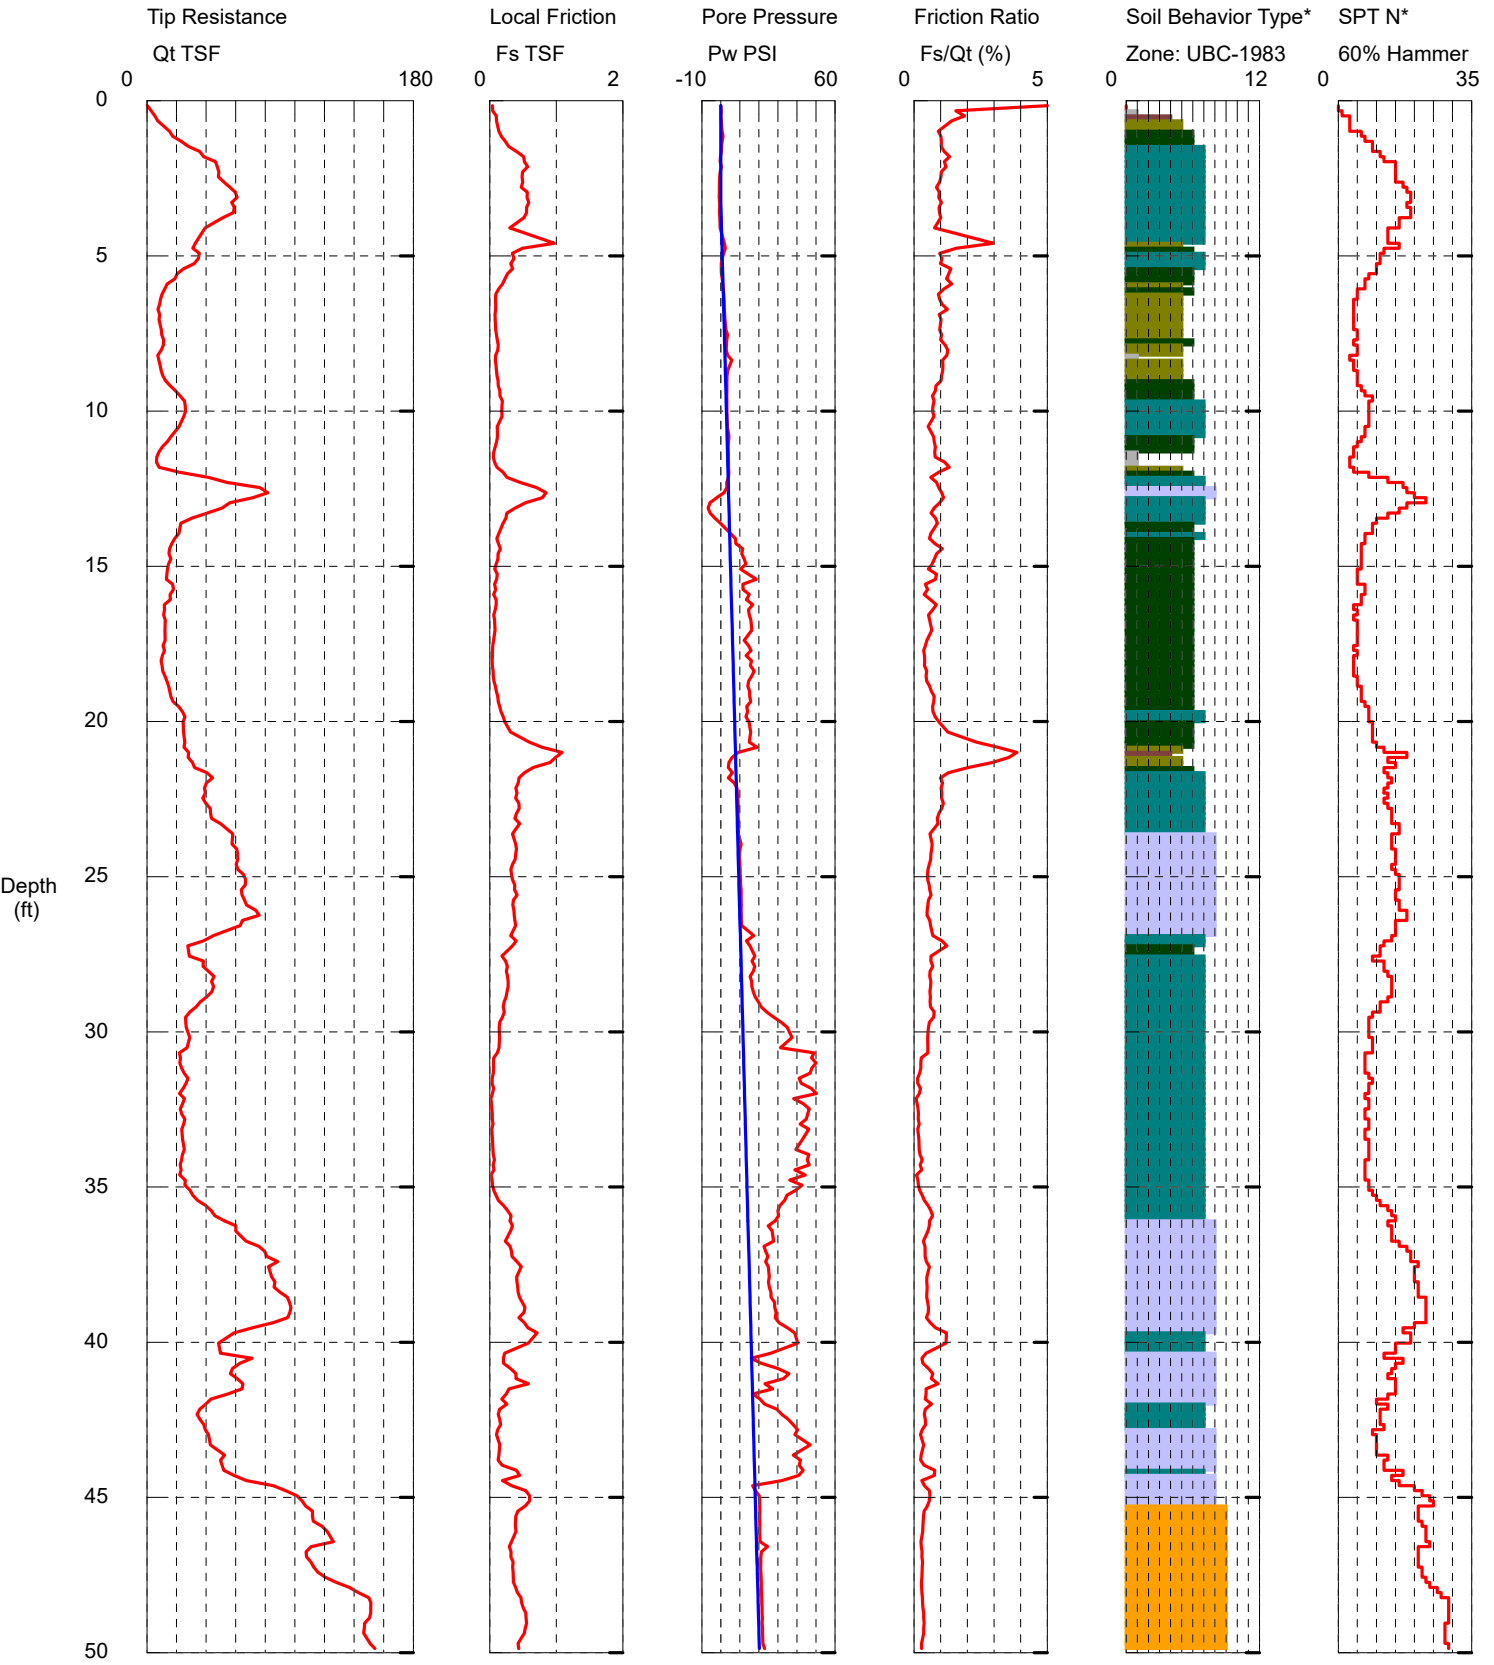
Operator: Pat Conroy
 Sounding: C-2
 Cone Used: DDG1702
 Groundwater: 3.3 feet

TABLE II: Test Location C-2**

Depth:	USCS Classification	Friction Angle (°)	Cohesion (lbs/ft ²)	Unit Weight (lbs/ft ³)
0 – 2 ft.	SP-SM	28	0	95
2 – 5 ft.	SP-SM	30	0	50
5 – 12 ft.	SP-SC, SP-SM	27	0	47
12 – 14 ft.	SP, SP-SM	30	0	50
14 – 20 ft.	SP-SC, SC	27	0	47
20 – 27 ft.	SP, SP-SM	30	0	51
27 – 35 ft.	SC, SP-SC	28	0	48
35 – 42 ft.	SP-SC	31	0	51
42 – 45 ft.	SP-SC	30	0	50
45 – 50 ft.	SP	36	0	57

Estimated ground elevation at location C-2, approximately +7 Ft

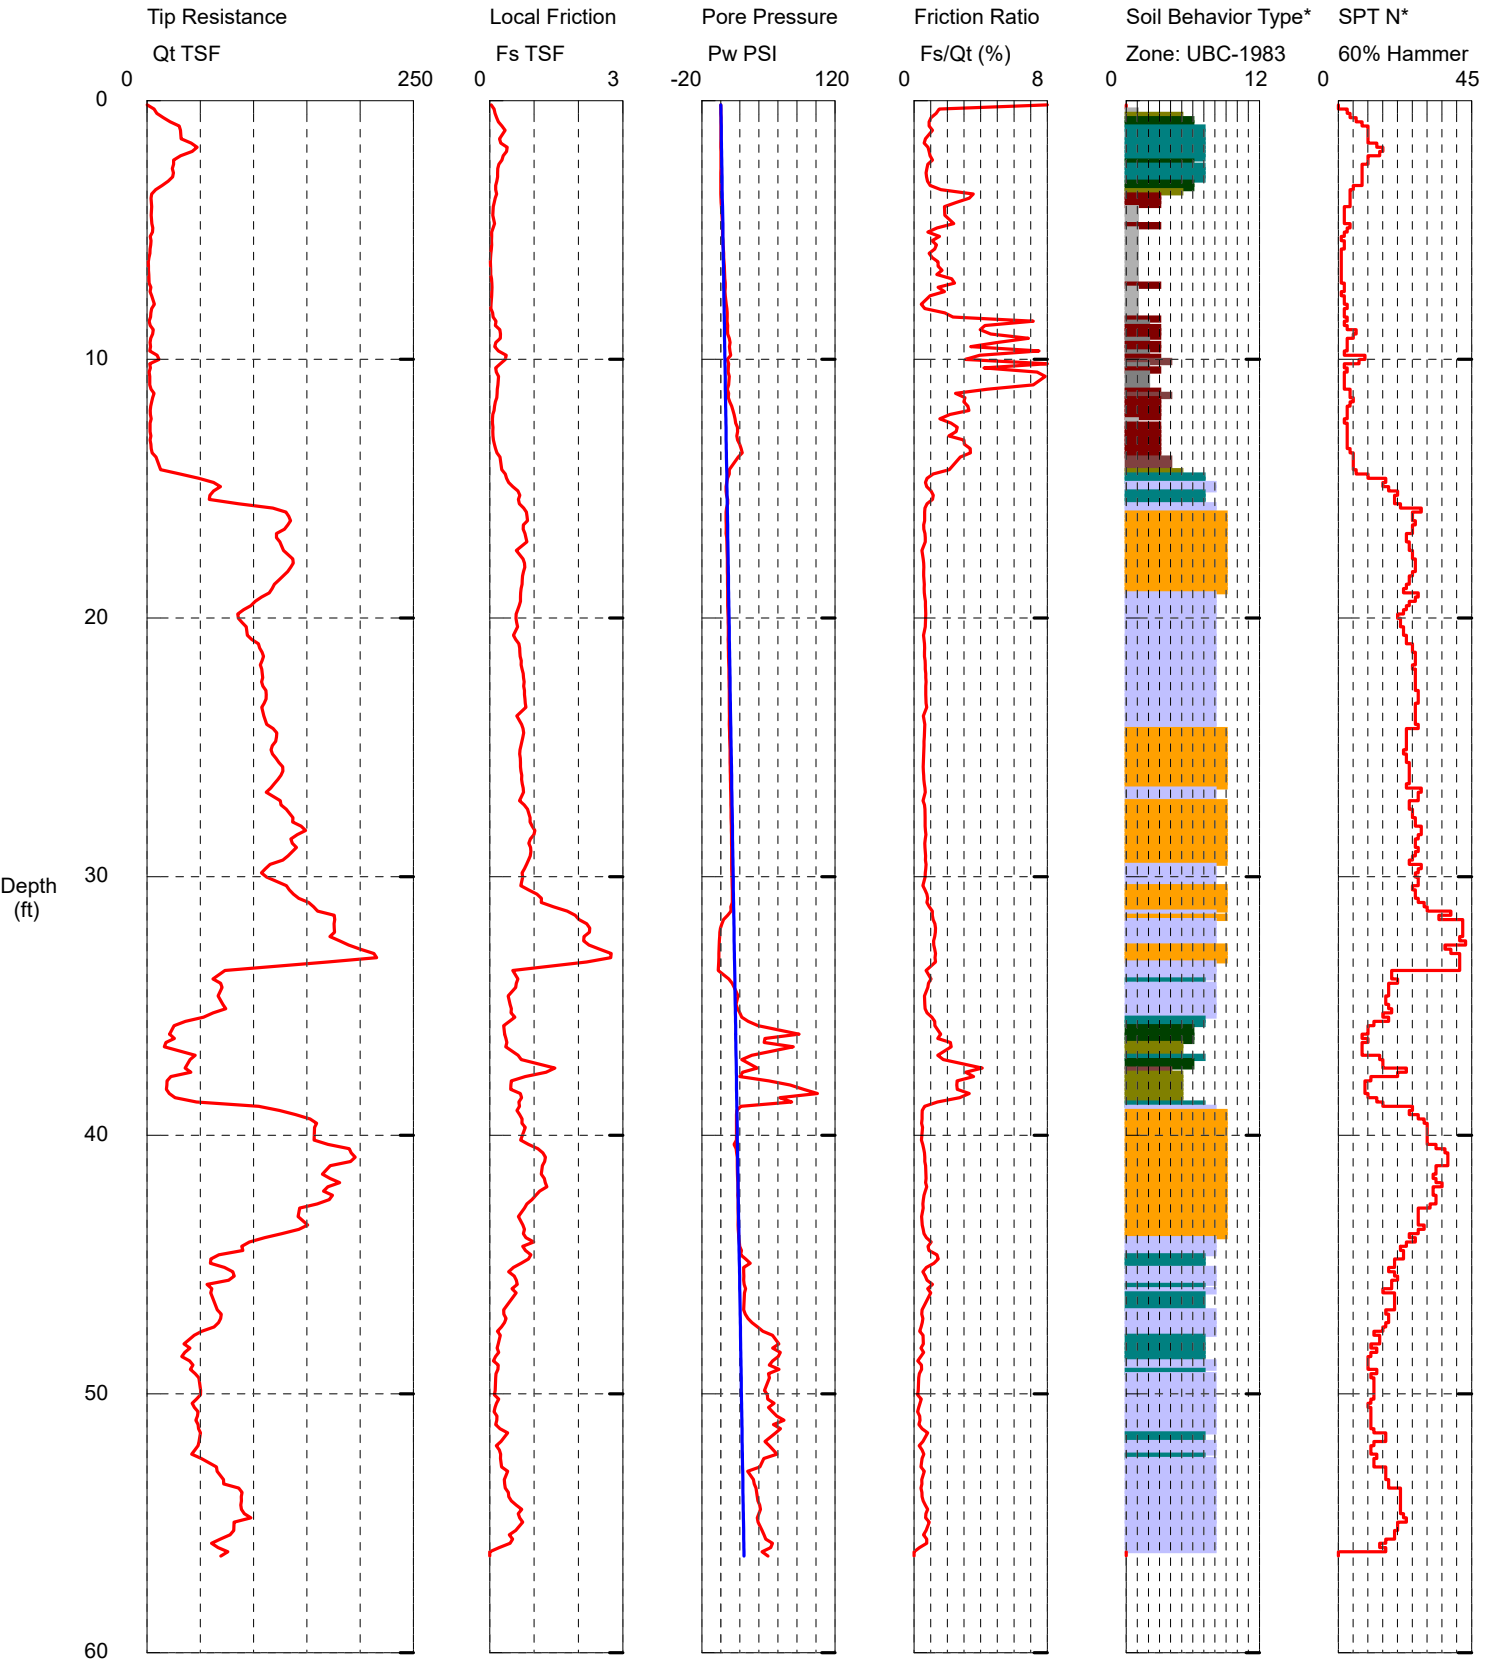
Operator: Pat Conroy
 Sounding: C-3
 Cone Used: DDG1702
 Groundwater: 4.0 feet

The soils encountered within the depth of our cone soundings and direct push borings were primarily sands, however were erratic between test locations. Organic soils (peat/peaty snads) were found at location C-3 at the southeast corner of the site. At this location the organic soils are very soft and compressible with moisture levels in the range of 90%. Based upon available areas, this location appears to have been within the former wetland areas prior to the site construction. The soils encountered throughout the remaining test locations were primarily sands. The sands generally consist of loose to medium dense layers with denser layers at deeper depths. Again, we anticipate variances in the soil conditions immediately behind the wall since these sands are likely in a loose to very loose condition.

TABLE III: Test Location C-3**

Depth:	USCS Classification	Friction Angle (°)	Cohesion (lbs/ft ²)	Unit Weight (lbs/ft ³)
0 – 2 ft.	SP-SM	28	0	94
2 – 15 ft.	PT	23	0	40
15 – 33 ft.	SP-SM, SP	33	0	54
33 – 39 ft.	SC, SP-SC	28	0	48
39 – 45 ft.	SP, SP-SM	35	0	56
45 – 52 ft.	SP-SC, SC	30	0	50
52 – 56 ft.	SP-SM	32	0	52

Estimated ground elevation at location C-3, approximately +5 Ft

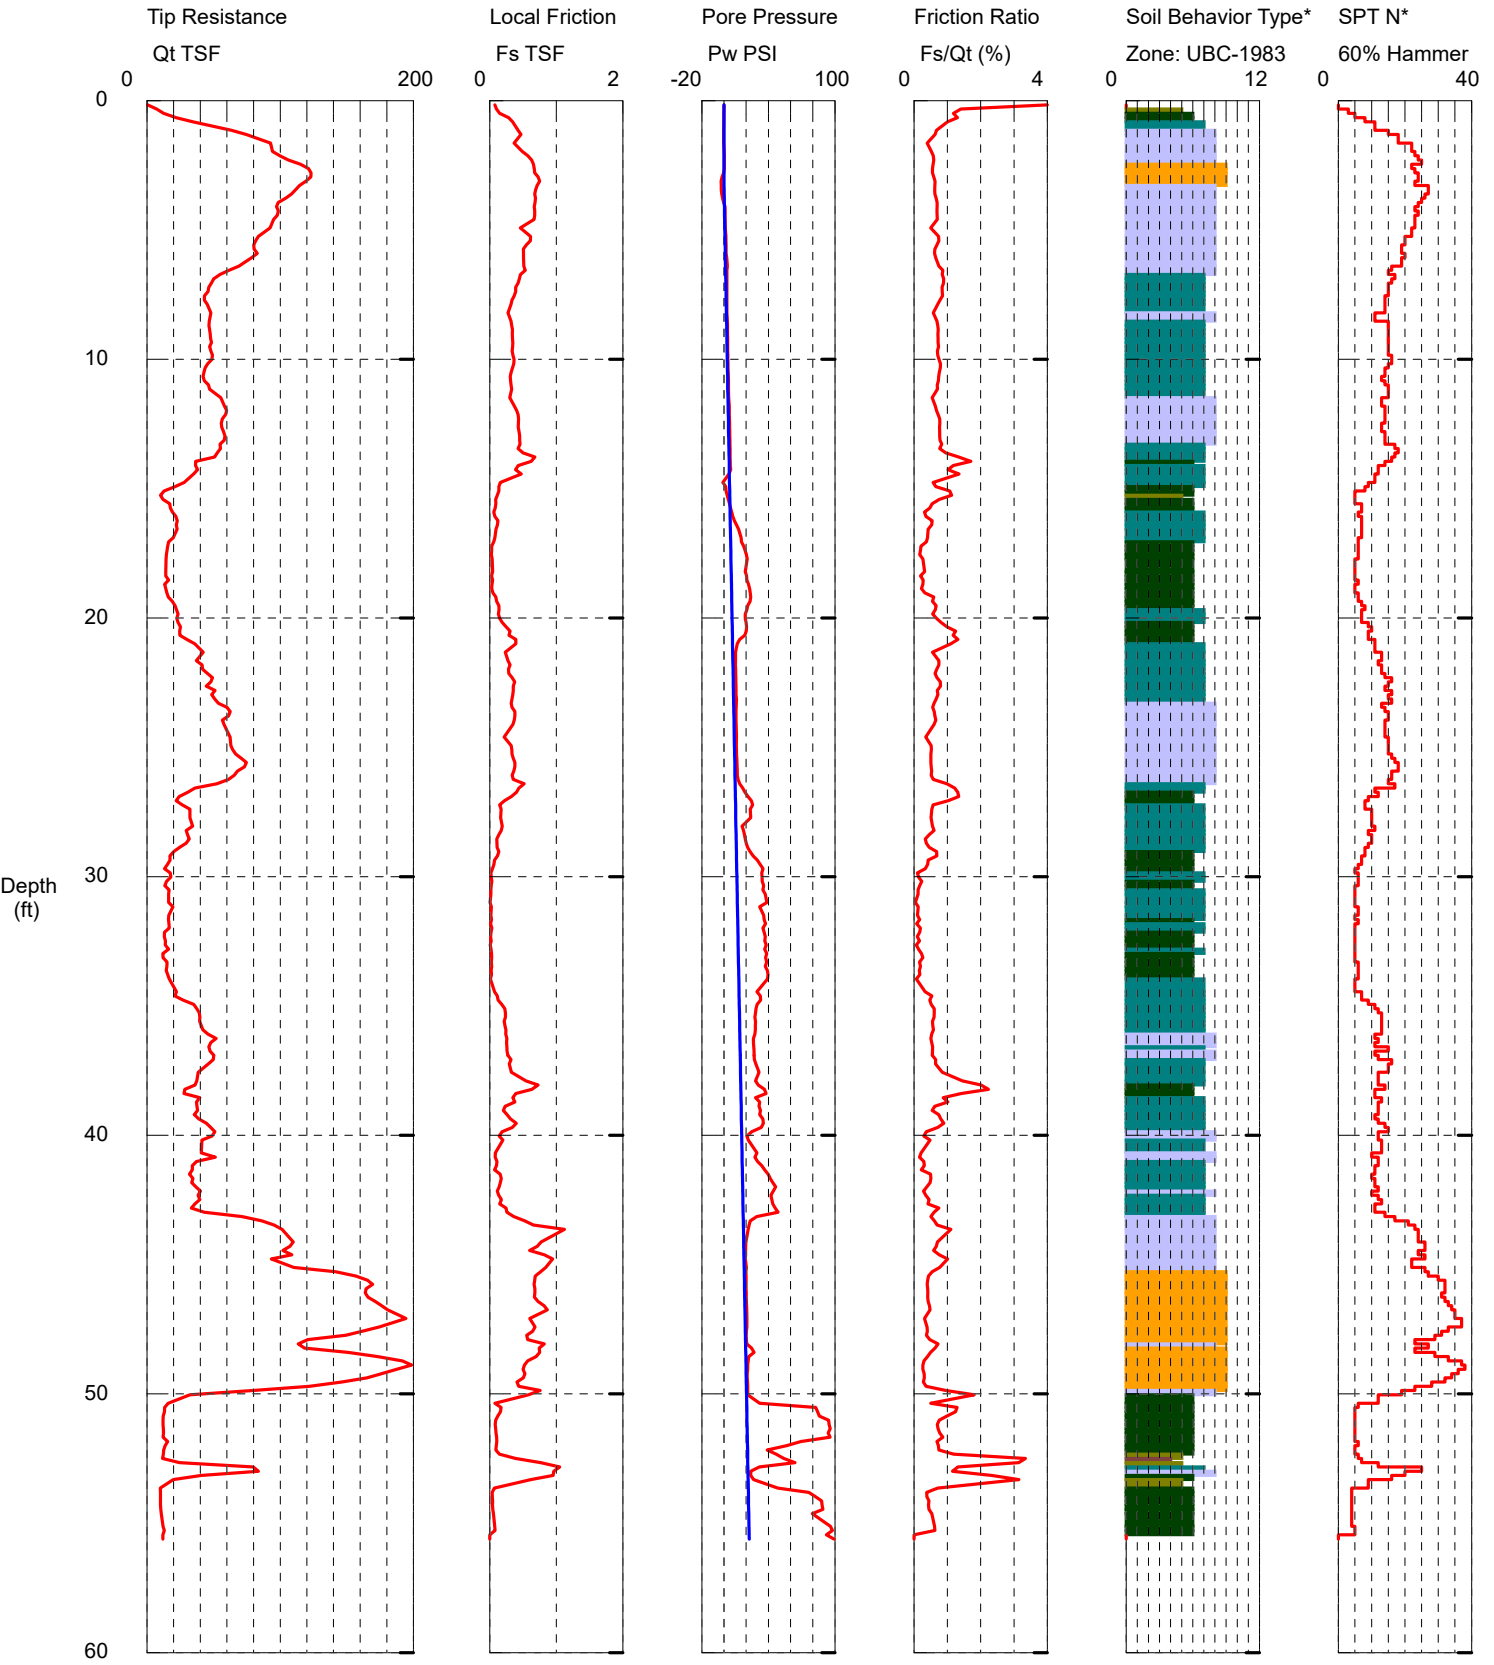
Operator: Pat Conroy
 Sounding: C-4
 Cone Used: DDG1702
 Groundwater: 4.5 feet

TABLE IV: Test Location C-4**

Depth:	USCS Classification	Friction Angle (°)	Cohesion (lbs/ft ²)	Unit Weight (lbs/ft ³)
0 – 3 ft.	SP-SM	27	0	95
3 – 13 ft.	SP, SP-SM	30	0	50
13 – 21 ft.	SP, SP-SC	27	0	46
21 – 27 ft.	SP, SP-SC	31	0	52
27 – 35 ft.	SC, SP-SC	27	0	46
35 – 42 ft.	SC, SP-SC	29	0	49
42 – 50 ft.	SP	35	0	56
50 – 55 ft.	SC	25	0	44

Estimated ground elevation at location C-4, approximately +6 Ft
